# Electrolux

19<sup>th</sup> July 2012

Supplier: Northumbrian Water

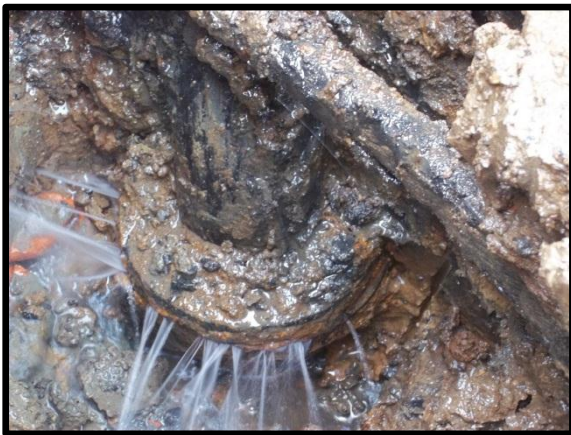
**Picture 1 – Leaking Flange Joint**

Further excavation around the restricted area finally exposed cast iron pipework with significant leakage on a flanged joint, see Picture 1. Further investigation revealed that the joint was part of a branch connection on the network with the branch serving a lone fire hydrant approximately 50 meters from the excavation site.

Water and silt was removed from the excavation and the scraping of debris from around the pipe revealed a double flanged bend. The flange bolts were removed from both flanges, before tapping the bend to release it from the gaskets. This allowed removal of the flange bend.

All appeared well and a simple flange cleaning was undertaken and replacement of new gaskets and bolts was all that was required to stop the leak. However, the flange size was 65mm and not 80mm as suspected. 65mm gaskets had to be sourced before continuing with the repair. The bend was refitted and all leakage on the flange bend appeared to have stopped.

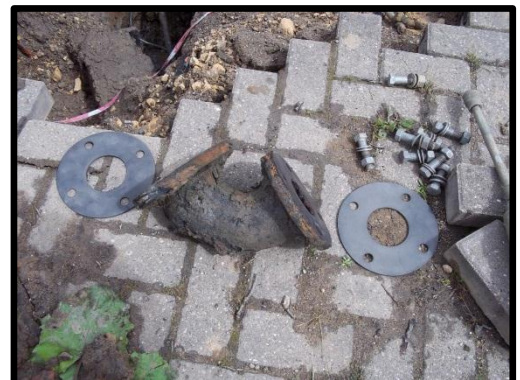
**Picture 2 – T Joint Removed**

However, there was a small spray that appeared to be coming from one joint. An attempt was made to tighten the joint and repair the leak; however, the leak remained and upon closer inspection revealed a small pin hole in the casting below the flange.

The effect of this is that the whole T-Joint required removal to rectify the leakage. The most economic method we felt, was to remove the offending T piece and join the main pipe supply run with a straight piece of pipe. This option was agreed with Alan Pratt and arrangements were made to return to the site on Friday 6<sup>th</sup> July 2012 to isolate the water and carry out these works.

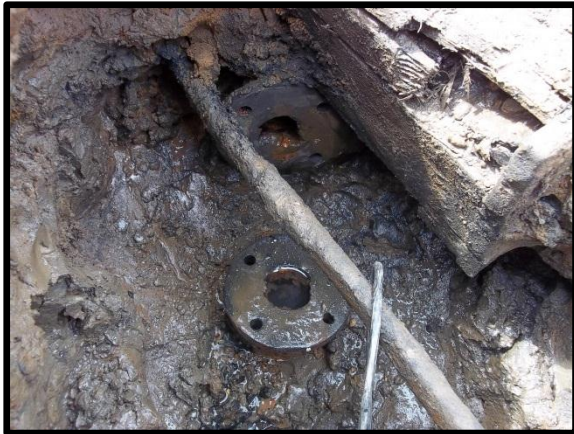
**Picture 3 – Where T Joint removed with live cable**

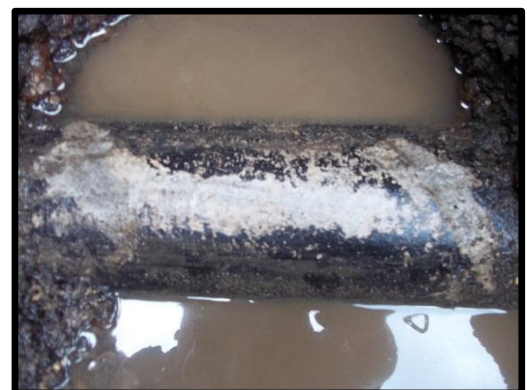
Further pipe tracing within the excavation still indicated the presence of a pipe although not in the assumed line of direction. Perseverance paid off as excavation carried out over the traced area revealed a 4" pipe. Closer inspection revealed asbestos cement material which, as explained to Alan Pratt, was a non-preferred material and therefore a repair was uneconomical and the line should be abandoned.

**Picture 4 – Asbestos Pipe**

Prolonged discussions between Alan Pratt and Electrolux came to the conclusion that the pipe should be abandoned.

Works were then undertaken to back fill the excavation at the second leakage site which exposed the 4" asbestos cement pipe. Sand fill was placed around the pipe before back filling the excavation to sub base level in readiness for the final concreting.

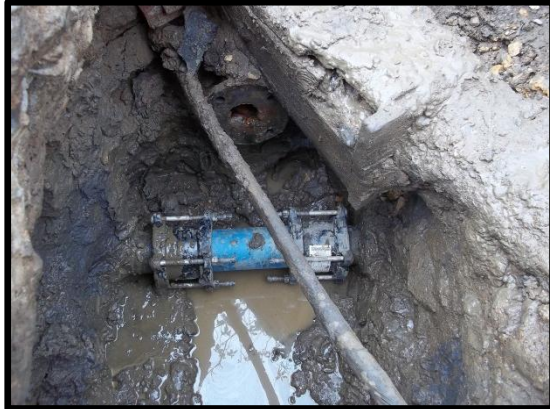
**Picture 5 – Section of New Pipe**

On arrival, we excavated the build-up of silt around the pipe work which had accrued during the recent floods in the area. Once the leaking T piece was exposed, it was cut out to facilitate a permanent repair using two new 80mm couplers and a section of new pipe.

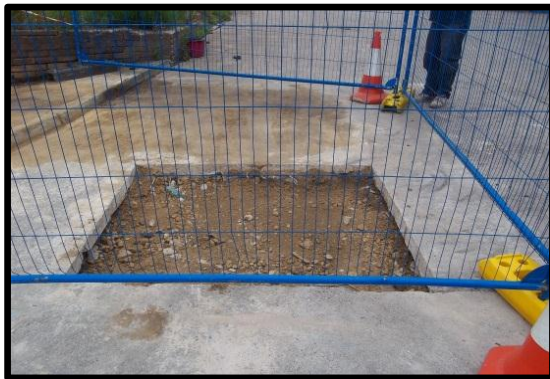
**Picture 6 – Backfilled before Re-instatement**

The water supply was then restored to check the integrity of the repair before back filling the trench with sand fill around the main and electric cables for protection and infilling the excavation with

stone fill to sub base level. Further sand was then used to make up the level to adjacent surface areas as requested by the client.
