# *McDonalds Kidderminster Leak Detection Site Survey*

11<sup>th</sup> July 2012

**Supplier: Severn Trent**

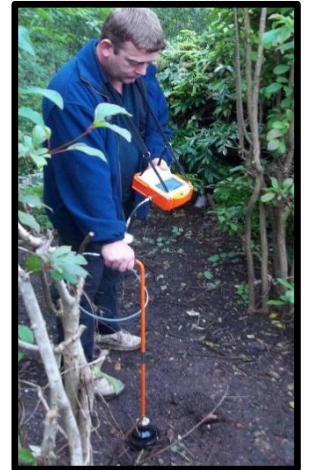
**Pic 1 - Gas Detection Survey**

Within a short period of time, there was a noticeable increase in the rate of gas injection which indicates that the tracer gas had started to escape from a leaking pipe. A subsequent gas detection survey produced a significant point of interest in the area of vegetation behind the gas meter chamber.

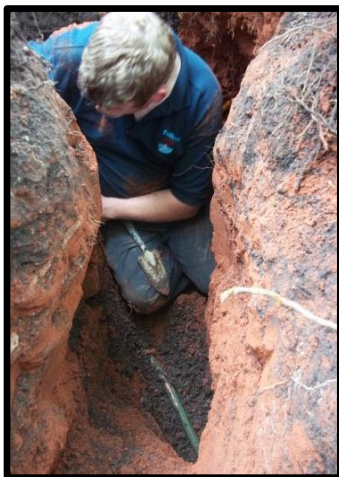
**Pic 2 - Excavation Site  
Depth of 1.1m**

Excavation commenced and although ground conditions were in our favour, the depth of the excavation was over 1.1 meters. (See picture 2) Initially there was some difficulty in locating the water pipe as it was not expected that we would be digging to a depth of this kind. The pipe was eventually exposed and found to be a 28mm copper supply.

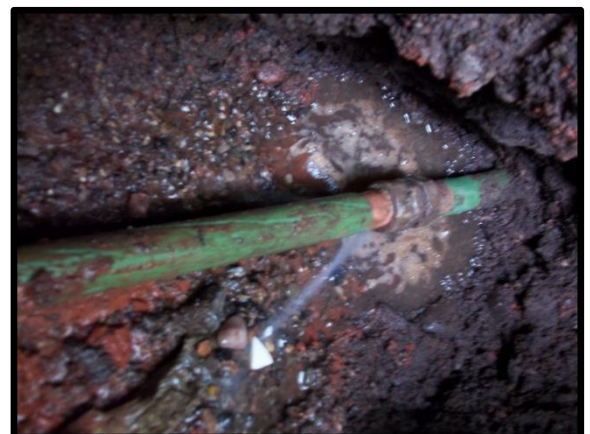
**Pic 3 – The compression joint containing the leak**

Now that the pipe had been located, the excavation was carried out further along the line of the pipe and exposed a compression joint containing the offending leak. (See picture 3)

The offending joint was cut out and replaced with a section of 32mm plastic pipe. The water supply was then restored at the meter which brought about a stationary meter register thus indicating that all leakage had been rectified.

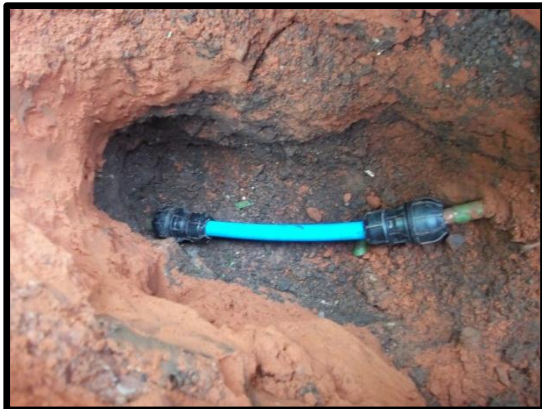
**Pic 4 – The 32mm replacement plastic pipe that repaired the leak**

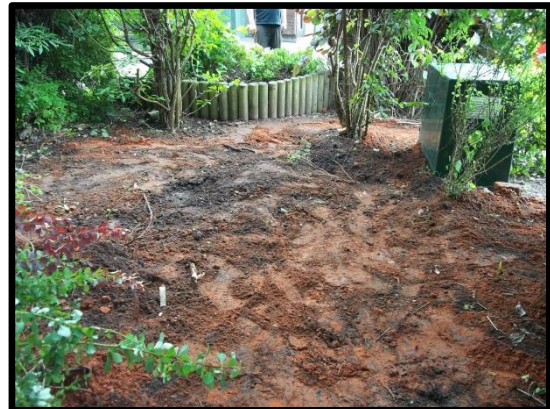
**Pic 5 – The excavation area has been backfilled and fully re-instated**

The excavation was then backfilled and reinstated by the time we were leaving site.
