10th April 2012

<u>Thorntons</u>, <u>Alfreton – Further Leak Detection 7th April 2012</u>

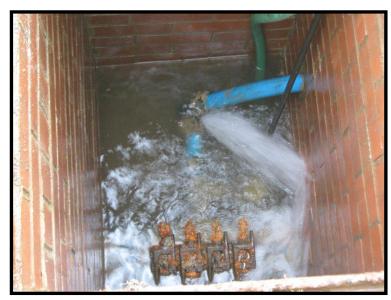
We continued the survey and listened on top of a cover that looked like a sewer/drain cover. There was a strong leak noise so we lifted the cover to reveal a 6" PVC main complete with ferrule and a 63mm branch. On the 63mm branch there is a wheel valve then a philmac elbow, the supply then crosses the road to the offices opposite. There is a serious leak on the philmac elbow within the chamber and we are confident that the leak is consistent with the losses being experienced.

Pic 3 - Meter Chamber with leaking elbow joint

- Repair both leaks identified on site at stop tap & chamber.
- Annual Savings £60,000
