Water Leakage Investigation Survey

Leisure Park, County Durham.

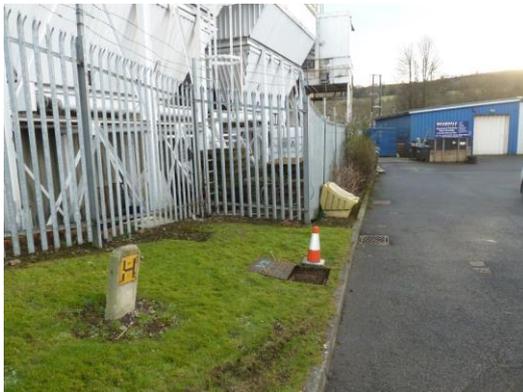
Meter location

The water meter supplying the park is located off site in the village itself. It is located in a medium sized chamber on the Industrial Estate, off Bondisle Way. From the meter, the exact route of pipework to the park is not known, though it is anticipated that it runs within the railway bridge deck that spans the nearby River Wear.

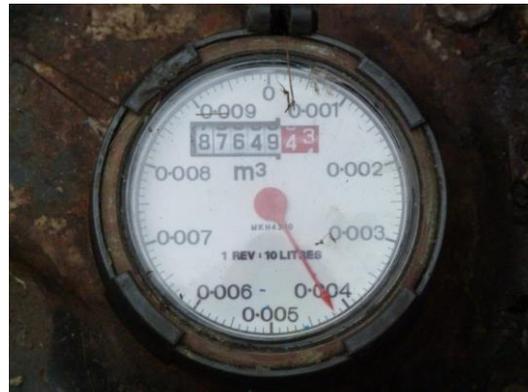
Meter

The meter was checked several times throughout the survey and was always found to be recording water consumption at a minimum rate of 58 litres per minute (just under 1 litre per second or 83 cubic metres per day).

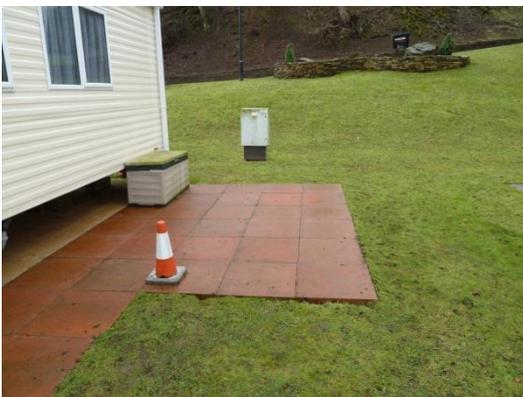
1. Riverview, between plots 56 & 57;
2. Sycamore Drive, supply pipe to plot 10.

Leak location 1 – plot 57 Riverview

1. Repair both leaks with appropriate fittings;
2. Fit automatic flow control devices to urinal cisterns in Crazy Bear bar/restaurant:
Cost to supply only 2No P.I.R Urinal Flush Controls £ 250 + VAT
3. Check all connections to caravans and replace pipe insulation or repair as necessary.
4. Inform H₂O the date and time the leaks have been repaired so we can download the water data logger and prove the water savings and then submit a claim for a leakage refund.

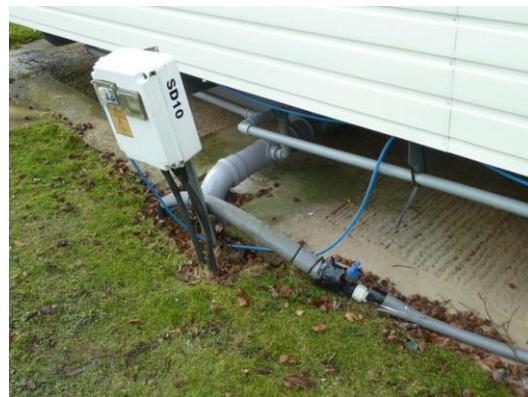
Leak location 2 – plot 10 Sycamore Drive

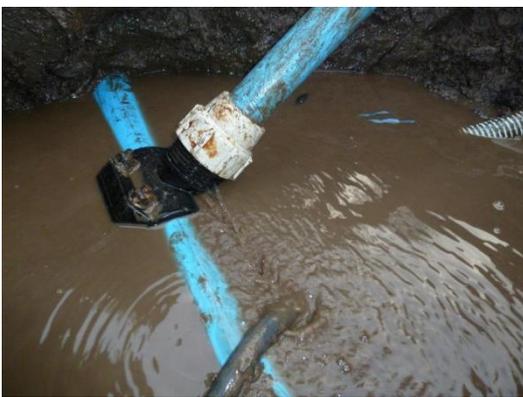
Leak location 1 – split fitting (pressure off)

1. Leakage confirmed to be 58 litres per minute (**approximately 83m³/day or over 30,000m³/year**) – **Cost £ 64,944 per annum.**
2. Two below ground leaks identified:
 - a) 57 Riverview – 50mm off 90mm MDPE connection. Split fitting and missing insert.
 - b) 10 Sycamore Drive – 20mm off 50mm MDPE connection – split fitting.
3. All connections (approx. 300) checked for leak noise and visual leaks;
4. Urinal cisterns in Crazy Bear bar/restaurant - no flow control devices fitted;
5. Pipework insulation missing from above ground pipework to a high number of plots.

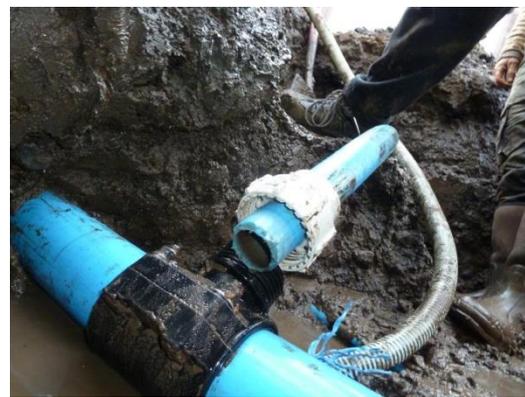
Leak location 1 – no insert fitted to 50mm MDPE

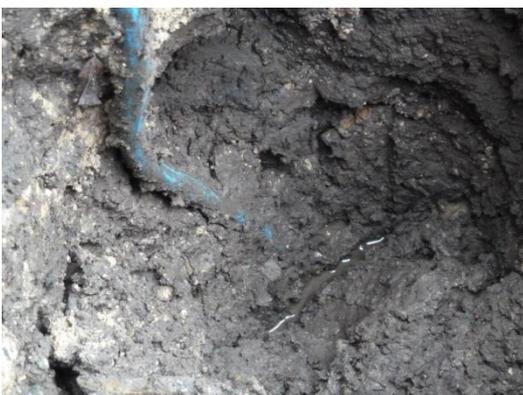
Leak location 2 – split on fitting

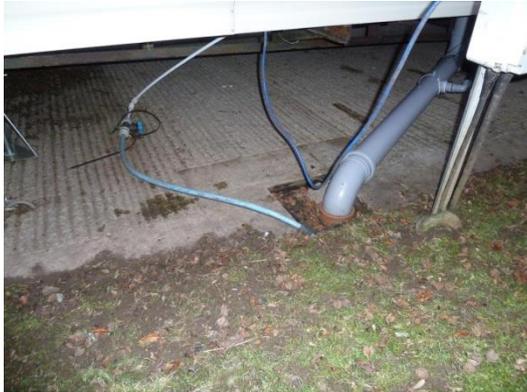
Throughout the leakage survey it was noted that all visible water infrastructure (service connections to each plot) was generally in very good condition. However, a number of plots were found to have missing or poorly installed pipe insulation:

Missing insulation

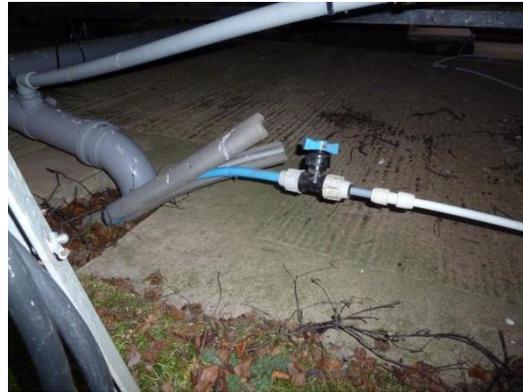
Poorly installed insulation
