Water Leak Detection Investigation Survey

20 May 2015

Holiday Village, Lancashire

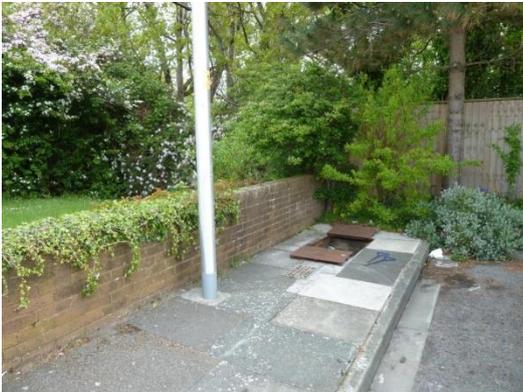
Meter location at end of Lawnswood Crescent

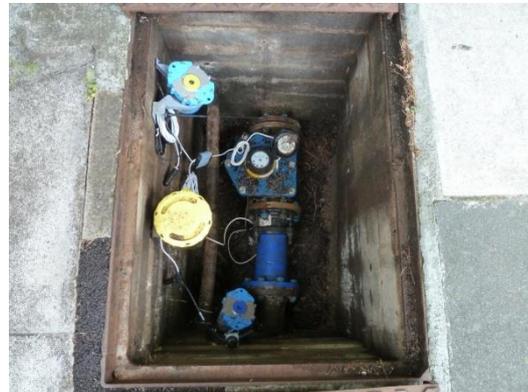
Meter chamber and loggers

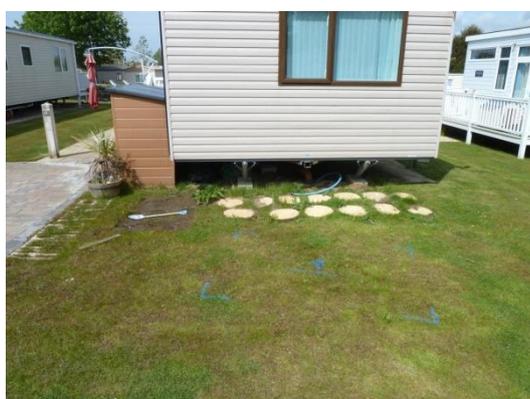
1. Regency – plot 17 – Large leak
2. Regency – plot 19 – indications of a reasonable leak but this could be as a result of noise transferring from leak at plot 17
3. Windsor – plot 101 – reasonable leak

Leak location 1 – Regency plot 17

1. Excavate, locate and repair all leaks with appropriate fittings;
2. Repair all minor above ground leaks;
3. Re-check flow of water during early hours to assess volume of any remaining leakage.
4. Long term, the lack of isolation valves will require almost a full leakage survey to be carried out each time the flow rate rises unexpectedly. It also means that each metered supply must be shut off to carry out any remedial work, unless carried out with the network under full pressure.

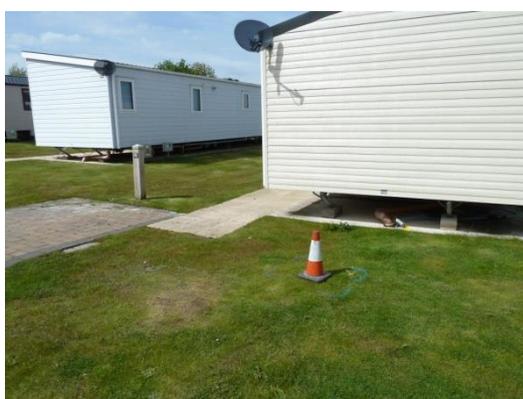
Leak location 2 – Regency plot 19

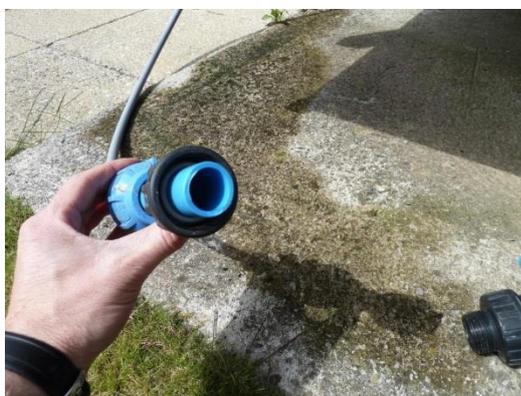
Insert missing from above ground pipework

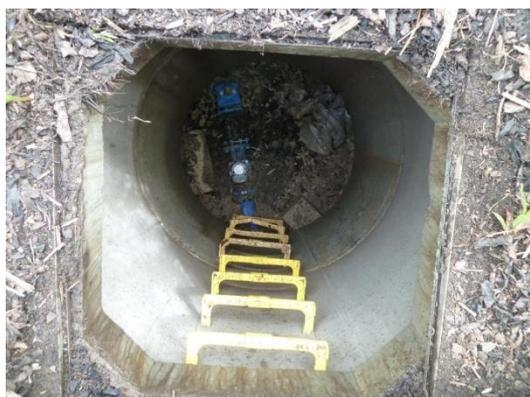
A sub-meter was located at top of embankment at rear of Regency 2 (thought to be out of use):

Sub-meter on embankment at rear of Regency 2

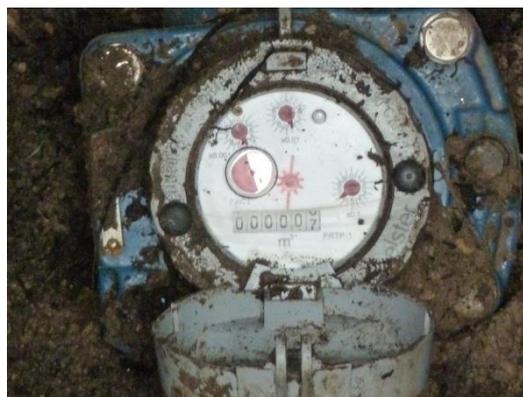
Sub-meter details (does not appear to be in use)

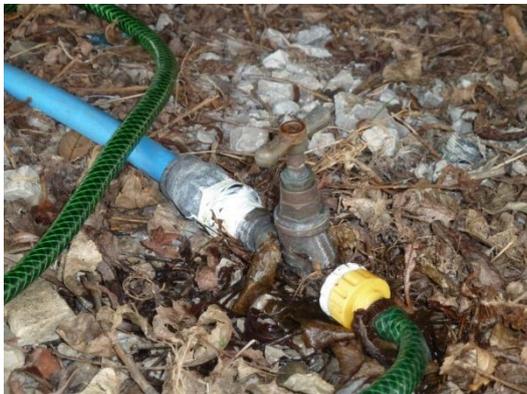
Leak on hose connection at Windsor plot 74

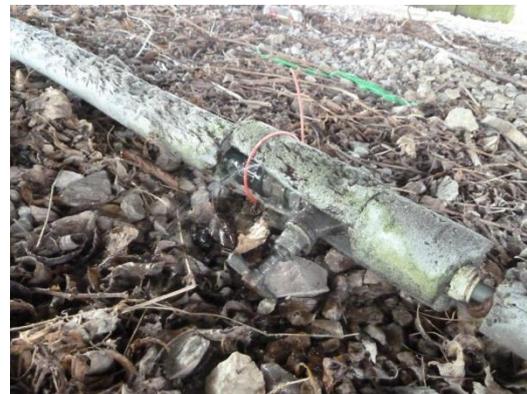
Leak on second stoptap to Windsor plot 74

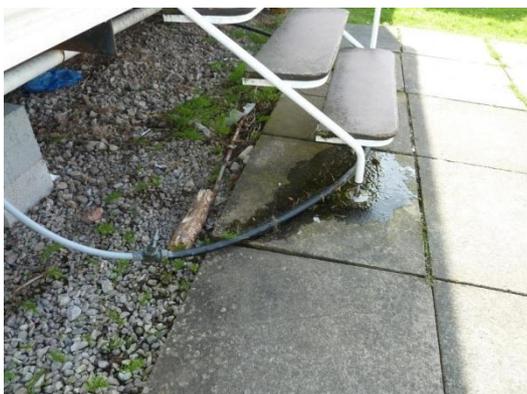
Leak on stoptap
