# Lyons Holiday Parks - Robin Hood Water Leak Detection Site Survey Report

26<sup>th</sup> August 2015

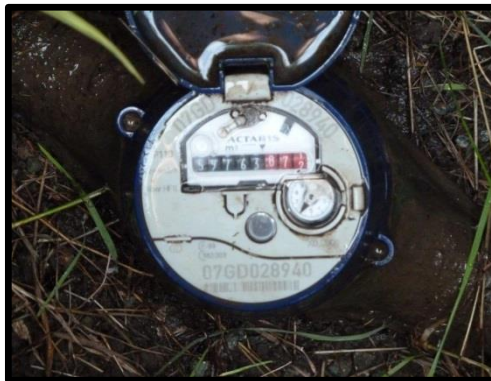
We identified the water meter on site as meter 07GD028940 reading 59749m<sup>3</sup> at approx. 09.30am and approx. 59763m<sup>3</sup> at 18.30pm. The consumption in between these two readings equates to 14m<sup>3</sup>, which gives an hourly usage of approx. **1.5m<sup>3</sup> per hour** and **approx. 37m<sup>3</sup> per day**. This equates to a **daily cost of approx. £109.89** and over the course of one year, this equates to an **annual cost of £40,109.85**.

Picture 1 – Welsh Water Meter 07GD028940

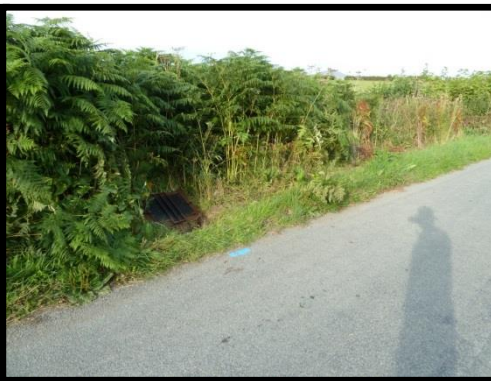
Picture 2 – Water Meter Location

The water meter supplying the park is located off site on the road between Llanfwrog and Bontuchel. From the meter, pipework is anticipated to run through fields before reaching a set of isolation valves in the bottom corner of the park.

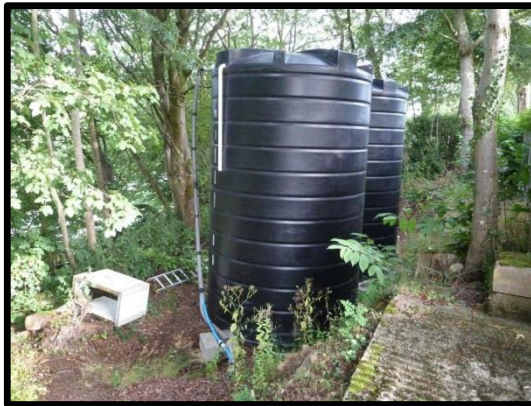
Picture 3 – Large water storage tanks & pump set

A check of all other water tanks and pumps was then completed to identify any unusually high flows of water. It was mentioned that the set of large water storage tanks struggled to fill, even during the night and with other areas of the park isolated. The two areas supplied by the tanks are a pumped area and a gravity fed section of the site. The pumps were checked and only found to operate intermittently which suggested that the pipework supplied from this point was leak free, leaving the gravity supplied section the only section of pipework with an unexplained high flow of water through it.

1. Excavate and repair identified leak with appropriate fittings then check water consumption by reading water meter regularly.
2. It is also recommended that consideration is given to evaluating the position of the existing water storage tanks (or installing new ones) due to the poor pressure experienced by some parts of the site.

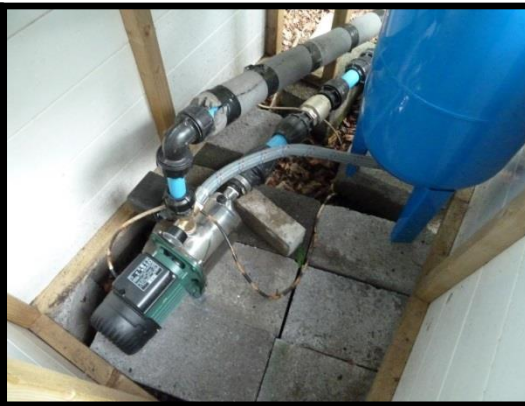
Picture 4 – Pump on outlet of large water storage tanks

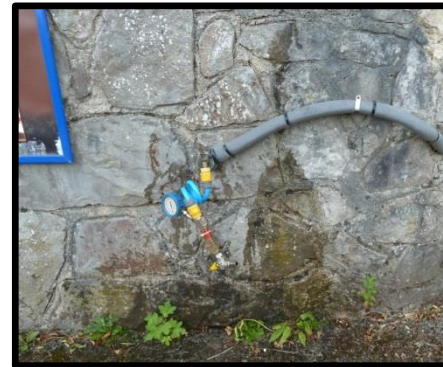
Picture 5 – Pressure & Flow testing equipment

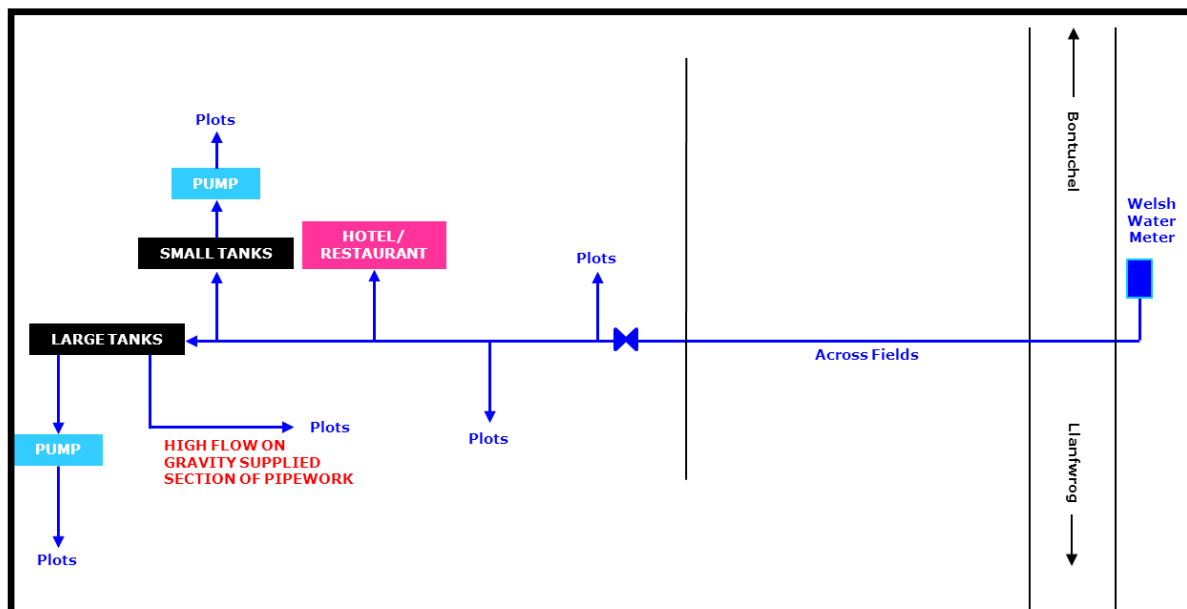
Picture 6 – A schematic plan of the site supply & layout

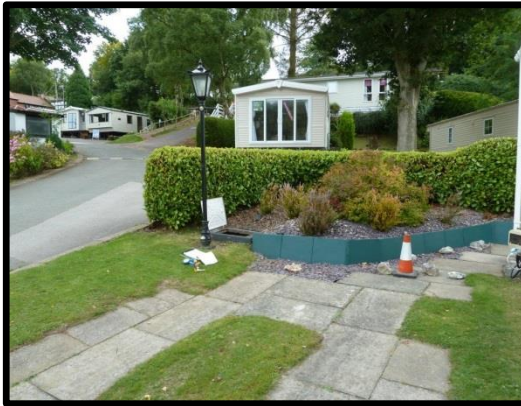
Detailed acoustic sounding was then carried out to confirm the exact point of leakage in the identified area. It is likely that the leak is close to or under a small landscape retaining wall at the side of the plot (Steve aware of where to excavate first).

Picture 7 – The leak location

1. Significant below ground leak identified on gravity supplied pipework. Leakage rate confirmed to be around 23m<sup>3</sup>/day.
2. Approximately 100 connections checked for leak noise and visual leaks;
3. Top of site (including hotel and restaurant) suffers from low pressure. Although 30 metres head of pressure is experienced in the lower parts of the park, some of the higher areas suffer due to the significant change in ground level. At times there is almost zero pressure in the main to supply the tank and hotel/restaurant.

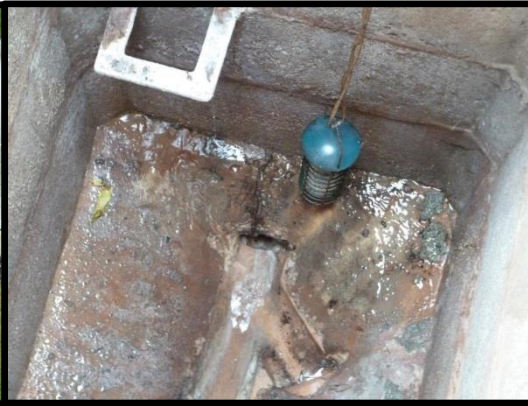
A number of drainage and water valve lids were also lifted and inspected to check for water ingress. In one particular area of the site, a continuous flow of clear water was found which was followed and found to be breaking through the side of the drainage chamber. Leak noise could also be heard on the surrounding slabs and pipework to the adjacent plot.

Picture 8 - Water breaking into drainage chamber
