# Leakage Investigation Survey

28 April 2016

**Holiday Park, Sussex**

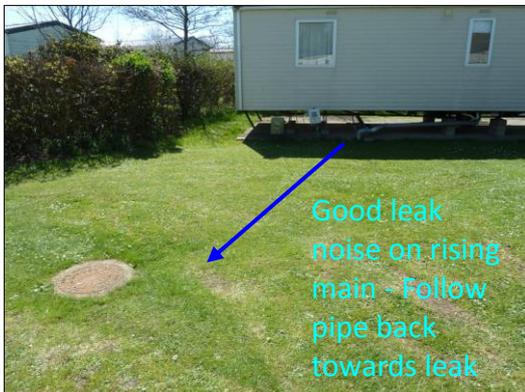
1. Good leak on supply pipe to **60 Slope Court** (could be on tee off 90 MDPE pipework?) Unable to achieve good correlation due to no leak noise being detected on any other rising mains. Excavate on rising main to no. 60 SC and follow towards leak;
2. Minor leak on supply pipe to **210A Holly Bank** – unable to correlate due to low volume of leak and unknown route of pipework. Leak possibly on connection to existing pipework by 210 MB;
3. Minor leak on rising main to **8 Hillview** – dig down on riser to locate leaking fitting;
4. Minor leak on rising main to **9 Hillview** – dig down on riser to locate leaking fitting.

Leak location 1 – leak on pipe to 60 Slope Court

1. Excavate, locate and repair all below ground leaks identified;
2. Repair all minor above ground leaks and water efficiency issues;
3. Check minimum night flow and confirm new leakage volume. Assess viability and costs of further work to identify these leaks;

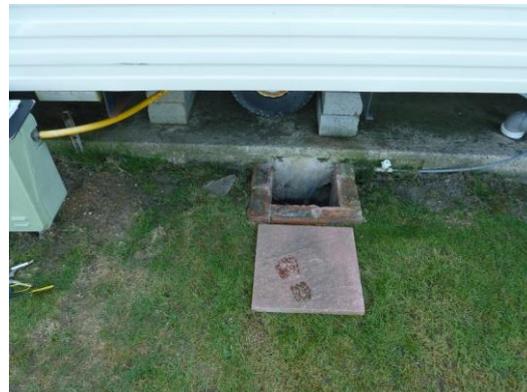
Leak location 3 – leak on riser to 8 Hillview

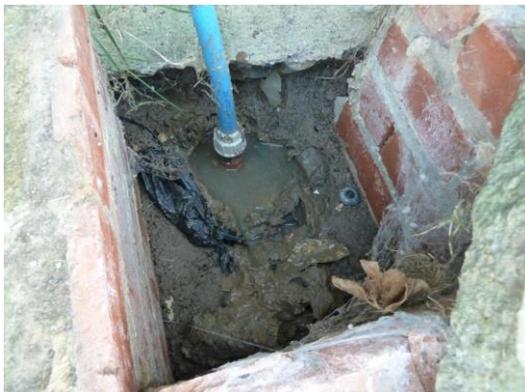
Leak location 4 – leak on riser to 9 Hillview

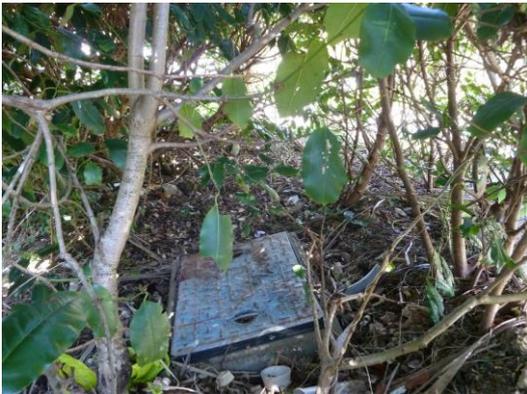
1. All water connections and underground fittings (stoptaps, isolation valves and fire hydrants) were acoustically sounded for leak noise and checked for visible leaks;
2. A number of above and below ground leaks identified (details above);
3. Simple step test attempted by isolating valves downstream of both PRV's but unable to confirm effectiveness without further proving and isolation work on other valves around the park. Several isolation valves could not be located, and others are hard to access under landscaping – all need locating and 'exercising' to check that they operate satisfactorily before any further step testing can be carried out;

Valve chamber located under bushes – needs to be made more accessible
