Leakage Investigation Survey

30 March 2016

| Trans Britannia Properties, M90 Commerce Park, Lathalmond, Fife KY12 0SJ |

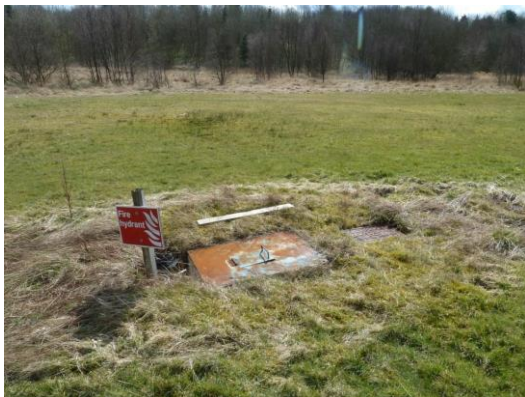
Meter location in grassed area

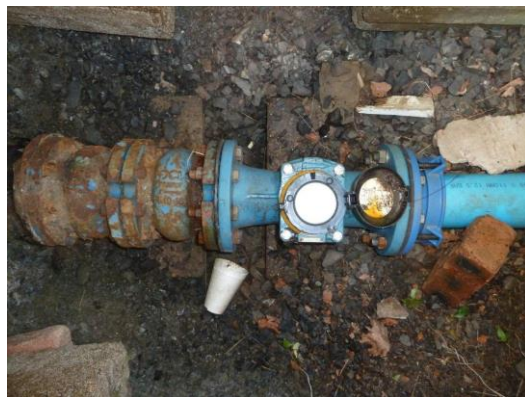
Meter

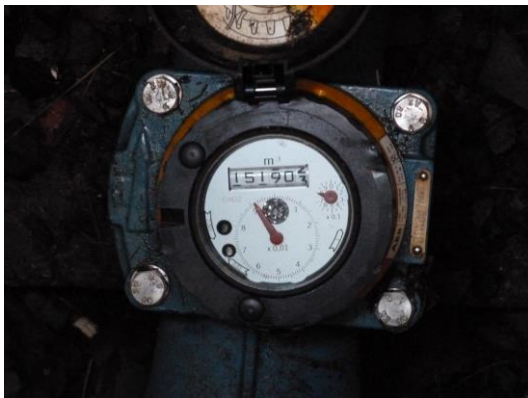
Meter reading

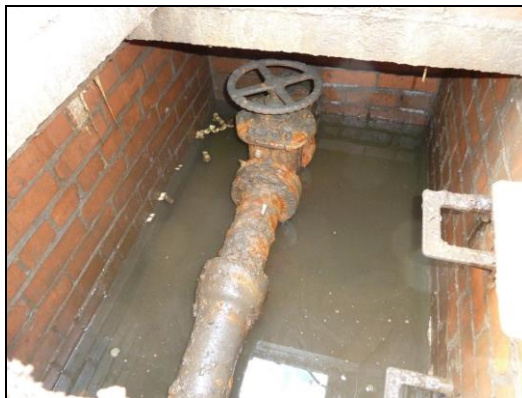
4" cast iron in chamber near gate house

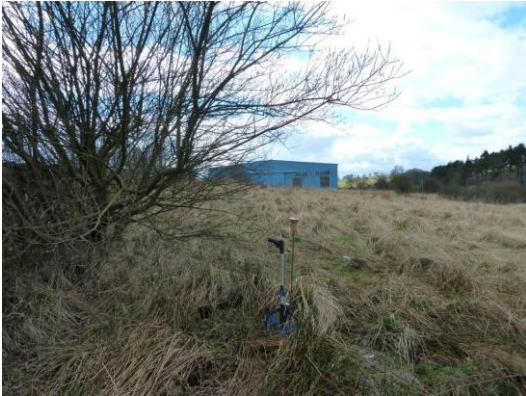
Leak 1 location

1. All water connections and underground fittings (valves and fire hydrants) were acoustically sounded for leak noise and checked for visible leaks;
2. A full correlation survey was carried out along the route of the 4" water network;
3. Two below ground leaks were pinpointed:
 - a) Significant leak on 4" cast iron main in field running parallel to B915;
 - b) Leak on small diameter pipework between buildings 1 (gatehouse) and 2;

1. Excavate, locate and repair all leaks with appropriate fittings;
2. Following the leak repairs, read meter and check flow rate to assess volume of any remaining leakage. Alternatively, consider installing a data logger on the meter due to the previous burst history of the site.

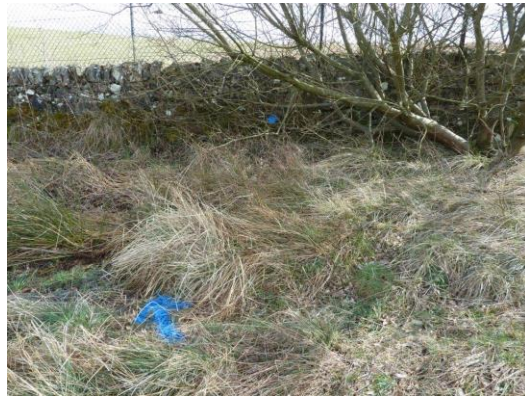
Leak 1 – visible water running. Blue mark on wall

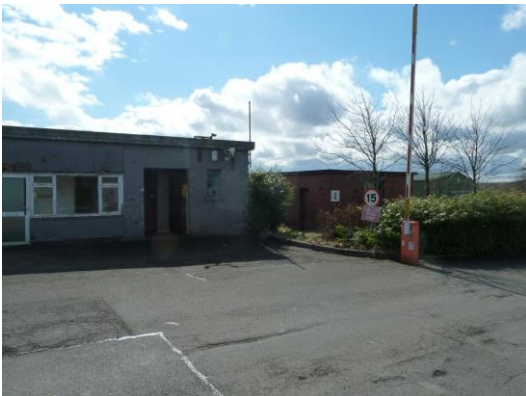
Leak 2 location between gate house and building 2

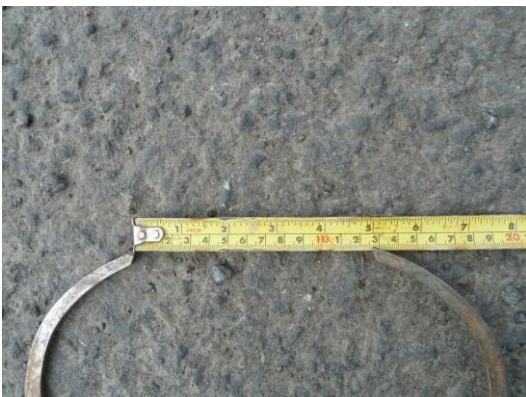
Repair information - calipered outside diameter of main 126mm

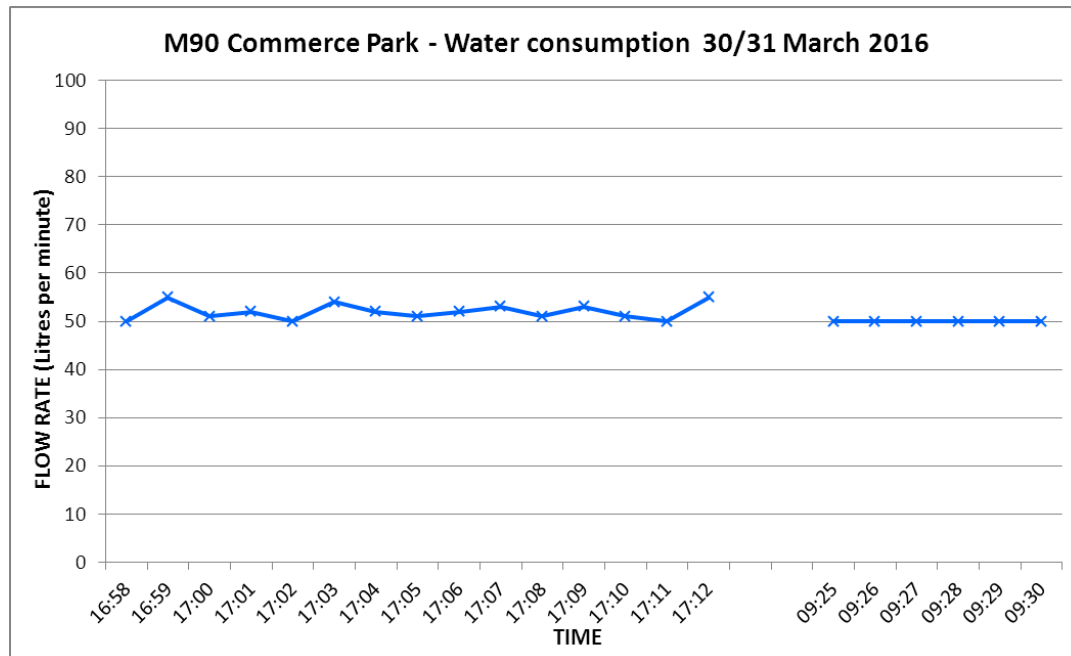
The water meter was read several times throughout the survey and found to be recording a minimum flow rate of **50 litres per minute** at all times. This equates to an excess daily consumption of **72 cubic metres per day**. The flow rate to the site overnight was calculated from meter readings at an average 52 litres per minute. An overnight flow of 52 litres per

minute equates 3.12m³ per hour (3,120 litres per hour) unaccounted water usage. This equates to an excess cost per day to site of £59.90 and over the course of one year, an excess cost of £21,864.96.
