# Leakage Investigation Survey

3 March 2017

| Holiday Park, Yorkshire |

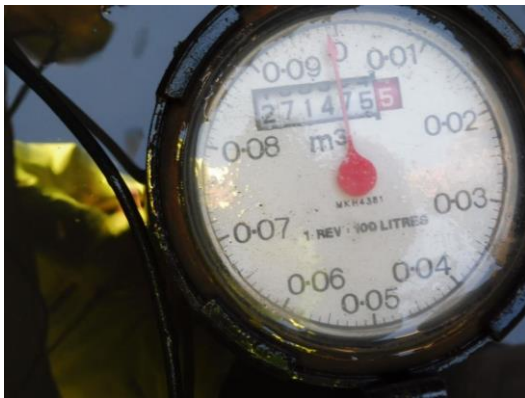
Main meter

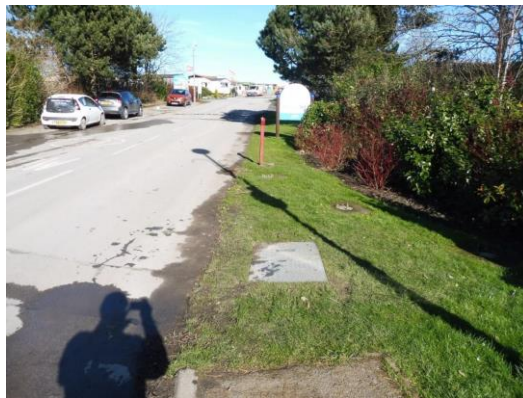
| Location | Meter located in large chamber in verge by second entrance to park.<br>Accessed with two large lifting keys. | | | | | | | | | |

Main meter location

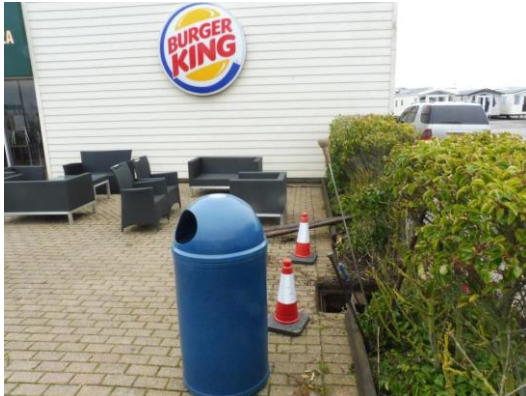
| Priority | Park Area | Plot | Fault | Comments |
|---|---|---|---|---|
| 1 | O/S Burger King | | Leak on 4" pipework | Site has requested quotation to repair. H2O to provide quote. |

Leak location by isolation valve outside Burger King

1. Excavate, locate and repair all below ground leaks identified;
2. Replace 2 no. large diameter isolation valves (1x4" & 1x6" – unable to confirm exact sizes though). One valve is located outside Burger King (adjacent to leak), the other is in block paving near owners area (site aware of this location); **H2O to provide quotation for replacement of x2 valves and repair of leak under block paving outside Burger King.**
3. Repair all minor above ground leaks;
4. Check minimum night flow and confirm new leakage volume. Assess viability and costs of further work of required.

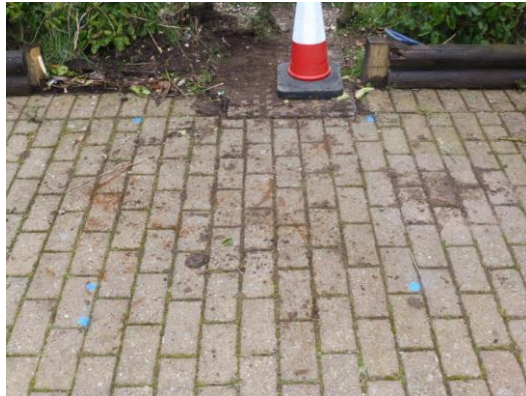
Leak location marked up

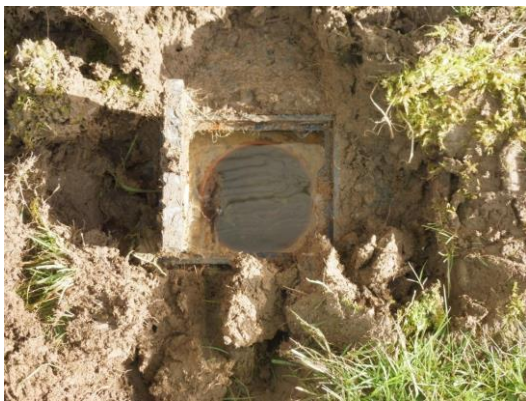
| Priority | Park Area | Plot | Fault | Comments |
|---|---|---|---|---|
| 1 | | 50 | Leak on stoptap | Repaired at time of survey |

Leaking stopcock - 50 Spruce Bridge

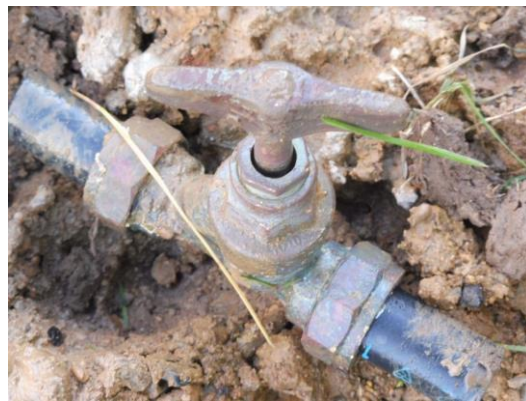
| Priority | Park Area | Plot | Fault | Comments |
|---|---|---|---|---|
| 1 | | 11 | Leak on stoptap | Repaired at time of survey |

Leaking stopcock gland - 11 Spruce Bridge

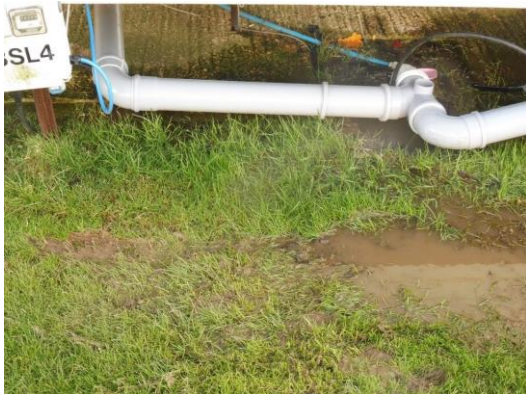
| Priority | Park Area | Plot | Fault | Comments |
|---|---|---|---|---|
| 1 | Birchtree Side | L4 | Leak on stoptap | Repaired at time of survey |

Leak at Birchtree Side L4

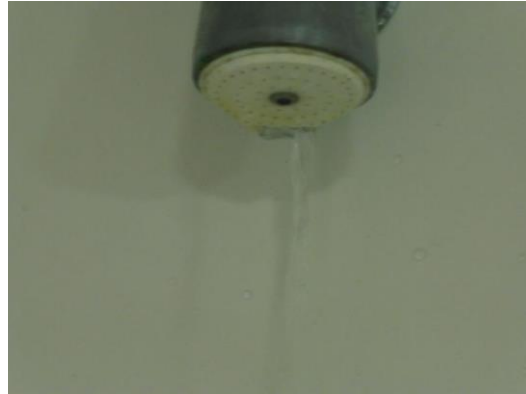
| Priority | Park Area | Plot | Fault | Comments |
|---|---|---|---|---|
| 3 | Swimming pool | | Disabled shower | Fitting leaking - 0.7 Litres/min |

Disabled shower - Leaking shower head
