Leakage Investigation Survey

26 January 2017

Holiday Park, West Wales,

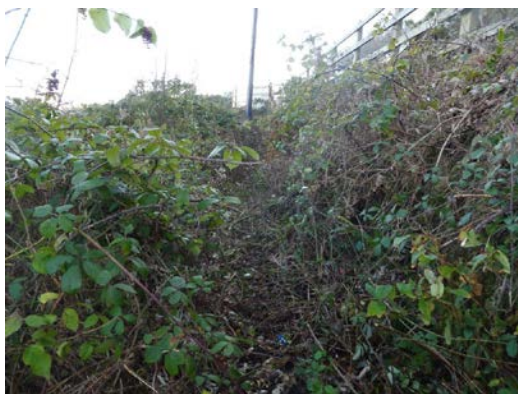
Meter 98765432 location - in brambles

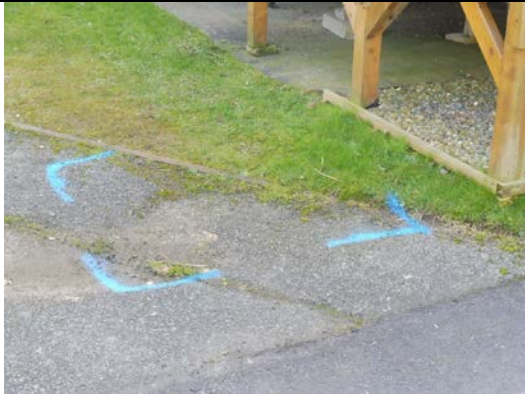
Leak location at Cardigan 19

1. Excavate, locate and repair all below ground leaks identified;
2. Repair all minor above ground leaks; take photographs of leaks & repairs. Upon completion of all repairs, notify H2O Building Services.
3. Review minimum night flow and confirm new leakage volume. Quantify savings and assess viability and costs of further work if required.

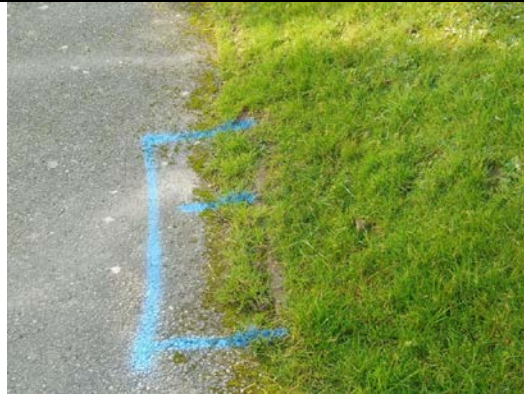
Leak location at Clwyd 25

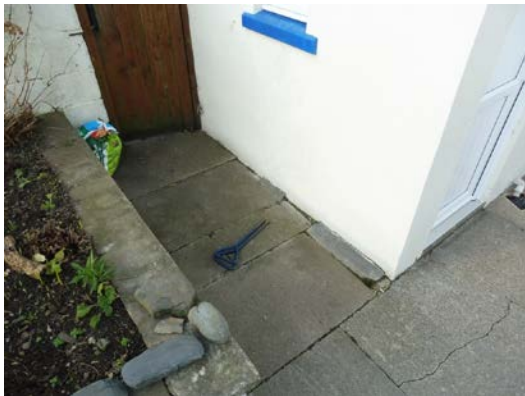
Leak location at Traethgwyn Cottages

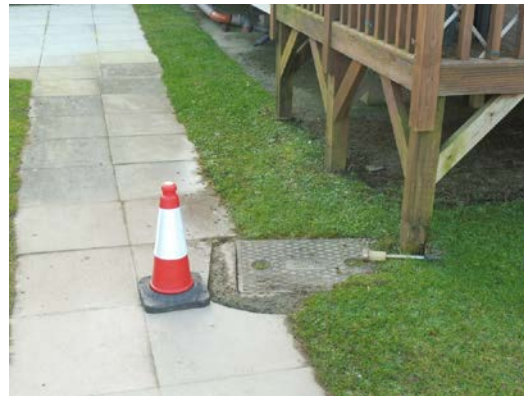
Potential leak location at Cardigan 9 (need to confirm when leak at Cardigan 19 has been repaired)

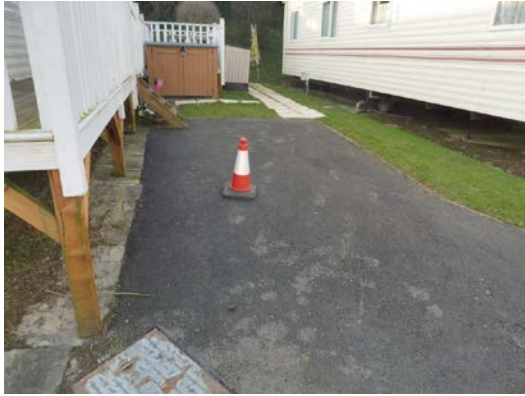
Potential leak at Powys 10 – isolate mains in this area if possible, to check water flow in drain has subsided, or trace out pipework

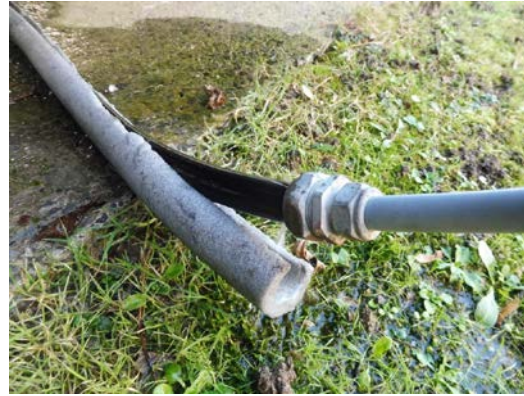
Leak on fitting Pembroke 25

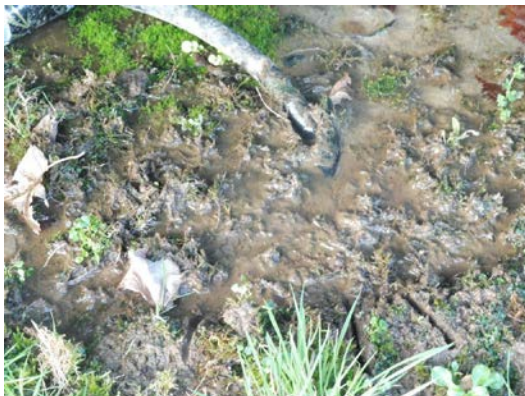
Minor leak at Hengell 28

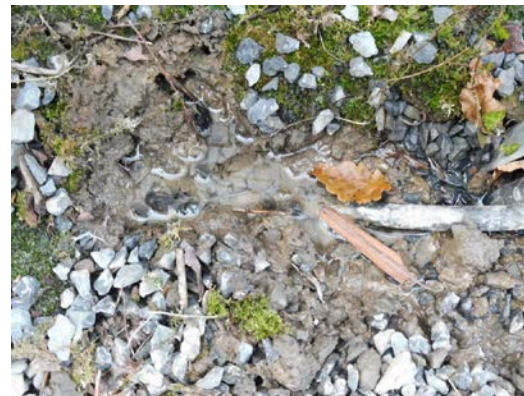
Minor leak at Teifi 42
