# Leakage Investigation Survey

**Client: Poole, Dorset**

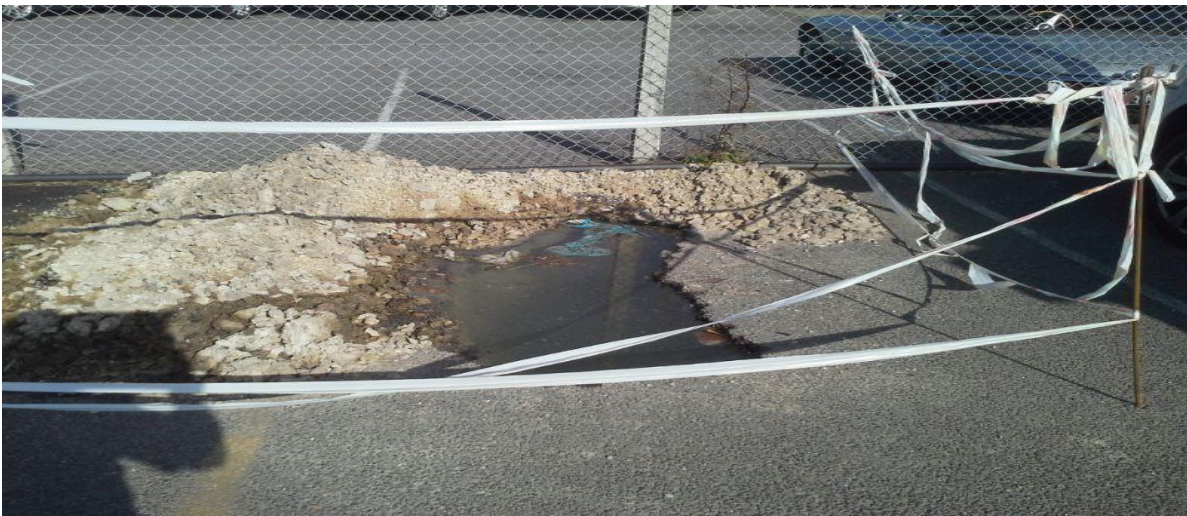
An excavation has been conducted on site, by another contractor where the supply pipe over a 2 day period was unable to be located. The slip trench was dug to a depth of 750mm 1800mm length and 650mm wide.

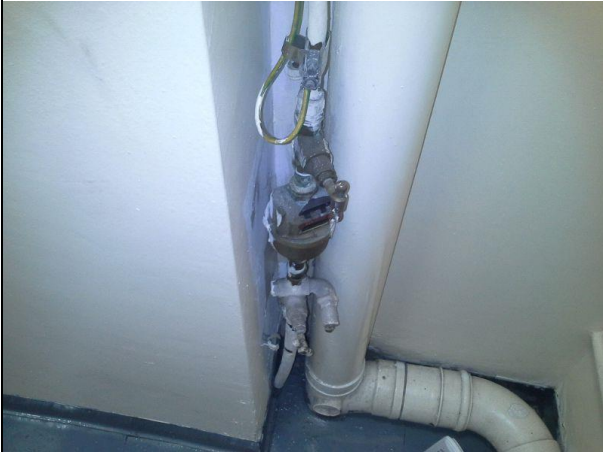
The Internal Water meter is located in the ladies toilet, the meter was not moving, the incoming supply is 22mm black poly, this is the meter charged on the account, the external meter is not charged by the water company.

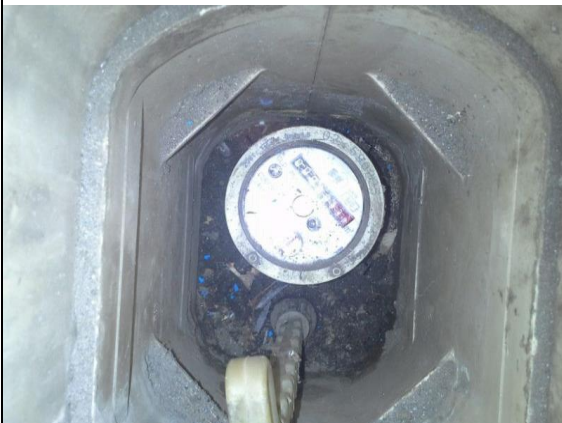
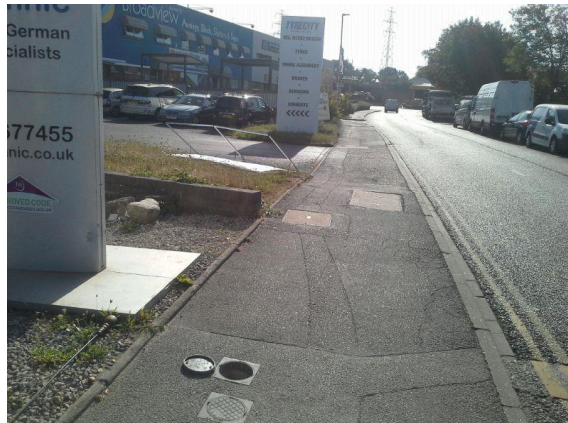
The External Water Meter on the footpath by the property boundary. The meter is moving. With the Internal supply isolated. The water loss was calculated to be 160 litres per hour, 3840 litres per day, this meter is not charged to the client account

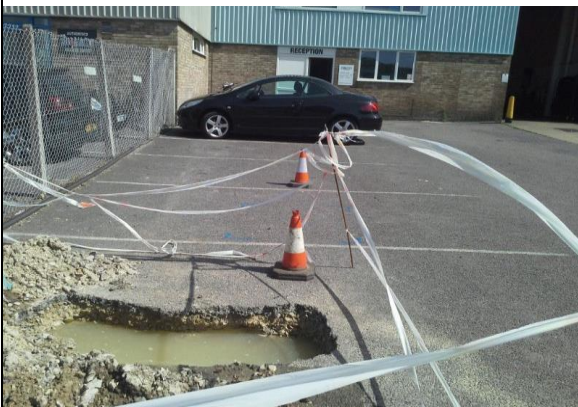
Suggested line of supply as indicated by the cones

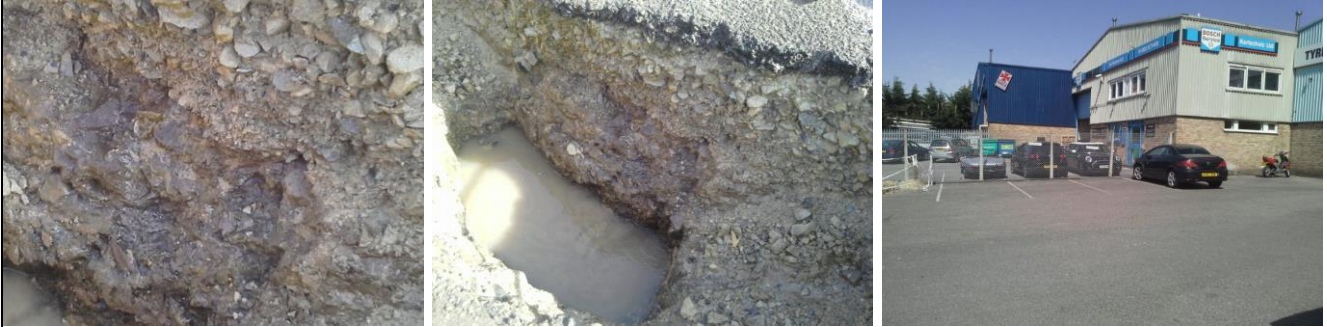
An Acoustic sounding of the internal and external water meter was conducted, a slight noise could be detected. The excavation was inspected and a slight water movement could be seen. The excavation was pumped out and the flow of the water could be seen traveling from direction of the building towards the property boundary

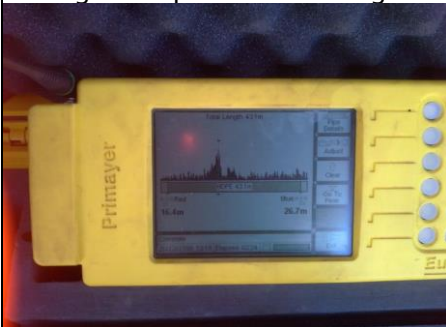
Two Leak Noise Acoustic Correlation were conducted, along an assumed pipe route. Both gave a positive reading with an indication of 16.4m and 17.1m from the rising supply

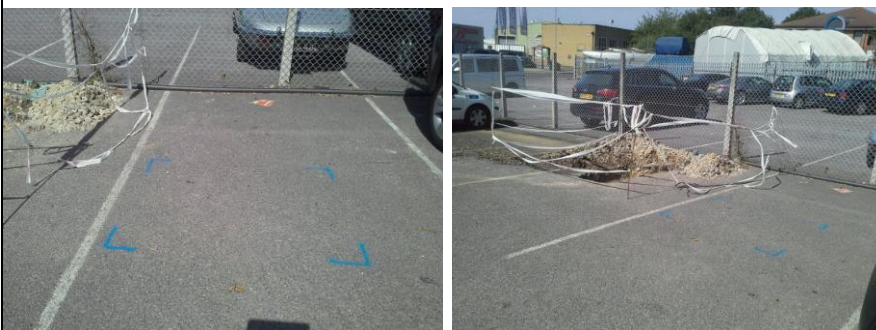
Surface sounding was completed with a listening stick and electronic ground microphone, highlighting the best noise near to the existing excavation

The best source of surface noise was marked with the centre position being 2.1m from the existing excavation and 2.7m from the boundary fence.

The water leak has been localised approximately 2.1m from the existing excavation.

To excavate over the marked area and locate the water supply, due to the current depth of 750mm of the existing excavation the water supply may be at a greater depth.

Locate the water supply unearthing the leak and repair.
