Leakage Investigation Survey

Client: Car dealership, Glasgow

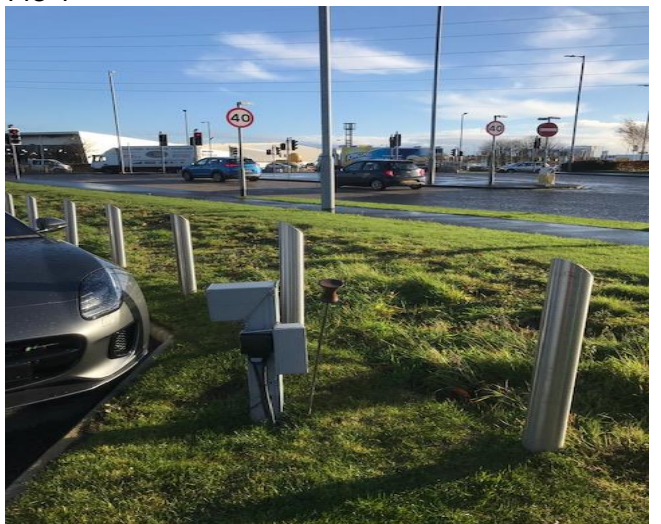
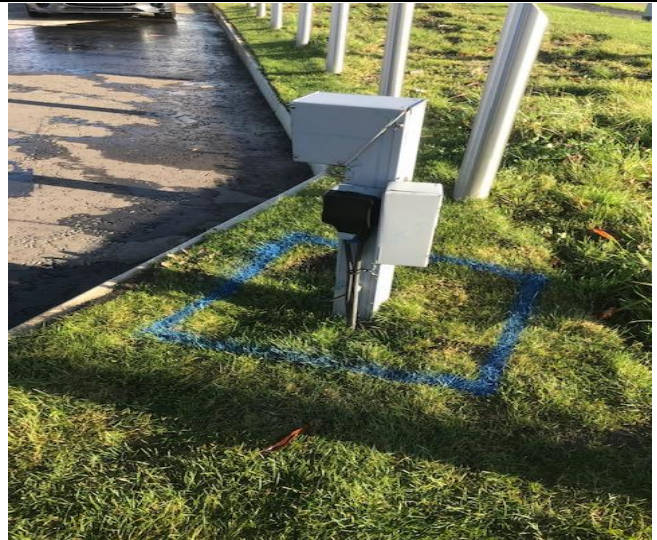
Once sounding began on the standpipes, leak noise could be heard almost straight away, on one of the standpipes, also subsidence was apparent. On checking out the standpipe a substantial leak noise could be heard, on probing of the grassed area clear water was being drawn up confirming a leak below ground at this location (pic 6,7&8).

Substantial leak located on pitch standpipe

Excavate and repair.
