Leakage Investigation Survey

Client: Large Leisure Site, Northants.

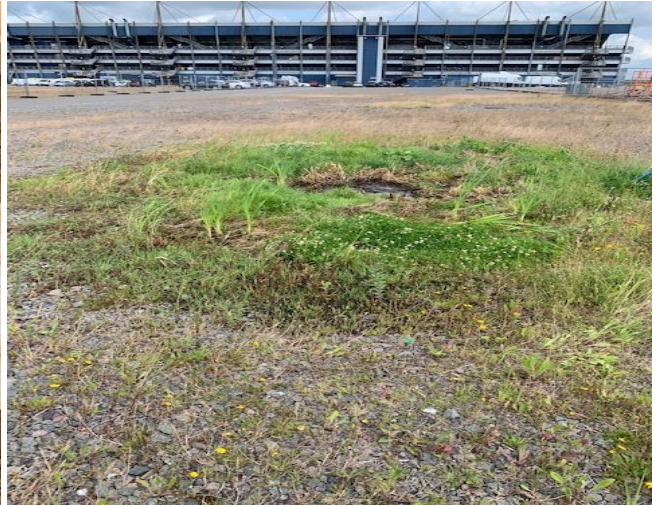
Pic 2

I began with looking at the small leak adjacent to the office buildings (pic 2), this was just a small section of wet boggy ground with two small bore MDPE pipes protruding out of the ground.

Efforts were made to obtain surface noise and noise on the pipe-work but nothing was evident, a water sample was taken and this showed chlorine almost instantly and confirming the water was mains water.

It is recommended that the area be excavated to uncover what is leaking and carry out necessary repair works.

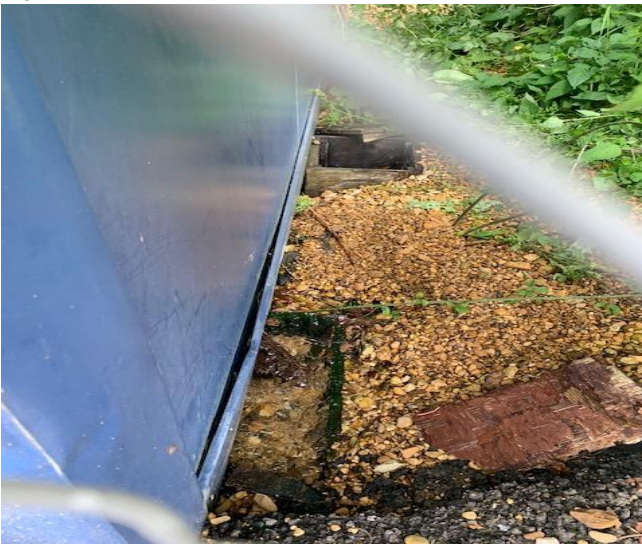
Pic 3

The second area of concern was the far left of the main stand in and around the old disused toilet blocks, subsidence is occurring in this area and is affecting the foundations to part of the stand.

There is a substantial amount of water showing from underneath one of the old toilet blocks (pic 3), on investigation with listening stick and ground microphone, it is presumed the leak is on the main or supply pipe very close to the toilet block in the tarmac carriageway area (pic 4). Water is also getting into the main drains in several places (pic 5) and the losses are estimated at 5m³ per hour.

Excavate areas of concern and carry out repairs where necessary

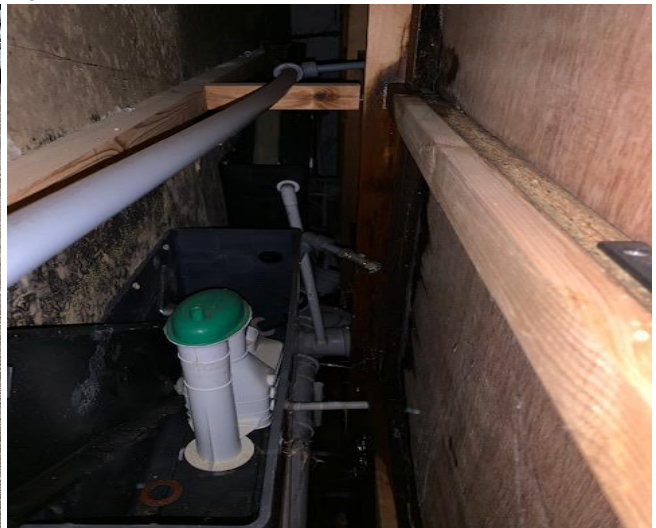
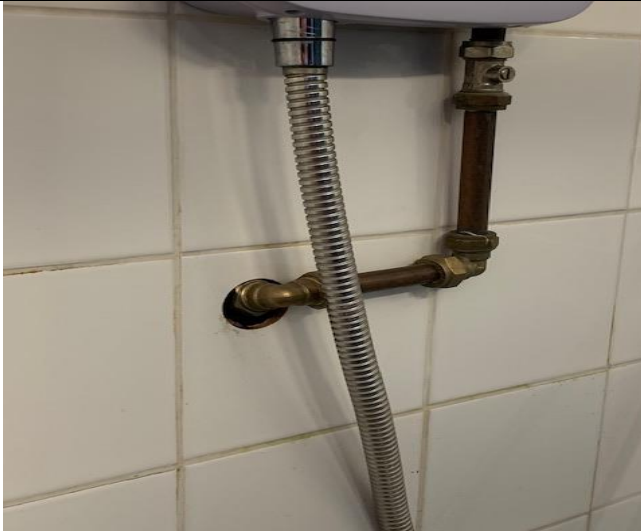
Further investigations were carried out around the site and additional leakage was located in two old toilet blocks near the drift circuit that are still in use, one is causing flooding on the floor and is a leaking 15mm copper pipe behind wall panels (pic 6&7) there is also a urinal cistern that was constantly filling and flushing (pic 8) this was located and turned down to just a drip to reduce waste.

Repair leaking pipe-work in toilet block

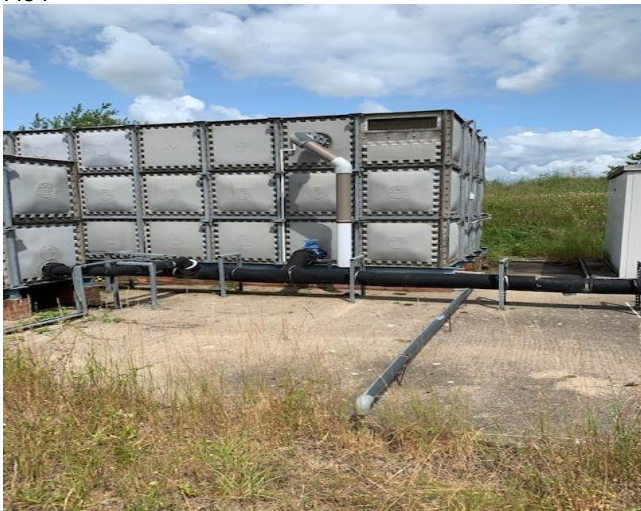
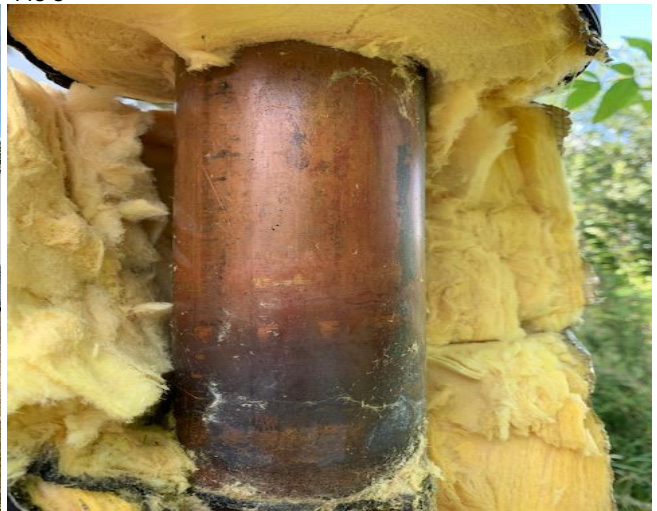
The area of the main tanks was also surveyed to confirm if a meter could be installed on the feed in to the main storage tank (Pic 9&10) pipe tracing was also carried out in the area using the copper rods method as the mains are all plastic once it leaves the tank area, the tracing appeared to be successful as all locations picked up all coincided with what the site plans indicated.
