Leakage Investigation Work

Client: Leisure Park, Northumberland

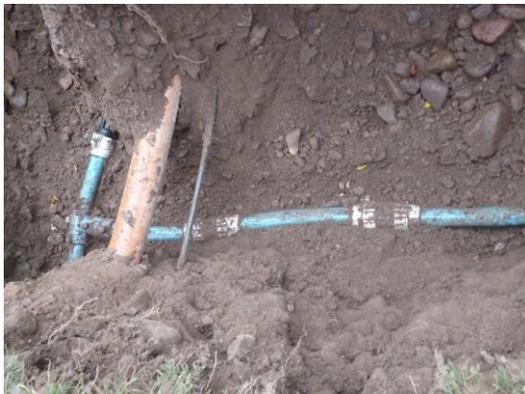
A hole was then excavated at the traced point to locate the tee piece, which was found to run together with other services (foul drainage and electricity cable) around Bamburgh Court (photo 1). From the tee piece, pipework was traced to the limit of the trace wire (approximately 120m) in both directions. Another hole was excavated near plot 183 to pick up the line of the pipework (photo 2).

Photo 1: excavation near plot 189

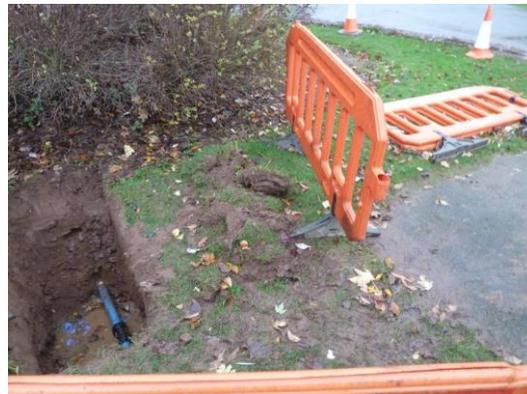
Photo 2: excavation near plot 183

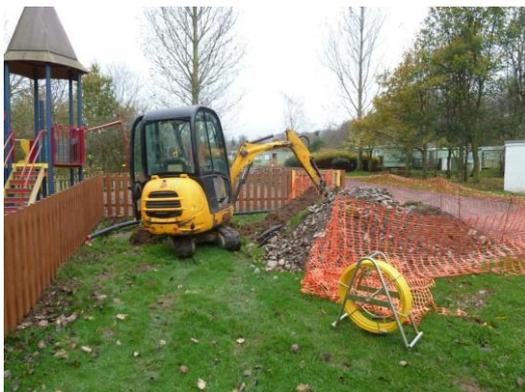
The marked area was excavated and immediately under the turf was found 2x concrete slabs. Under these were found plastic ducts full of soil, which when removed contained 2x brass stoptaps and a bit of standing water. The area around the stoptaps was excavated and the water supply reinstated. Once pressure in the network returned, significant leaks were noticed on both stoptaps (photos 3&4).

Photo 3: Excavation near play area

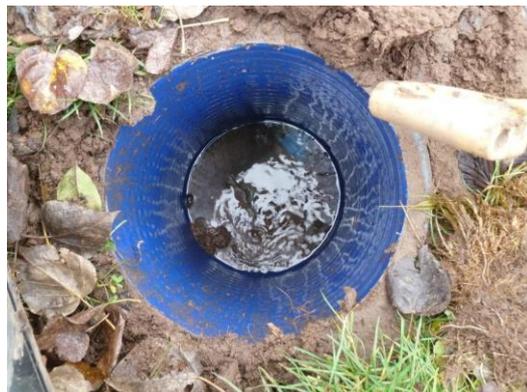
Photo 4: Leak on stoptap 1

Once the leaks had been identified, the water was shut off again and the leaks temporarily repaired.

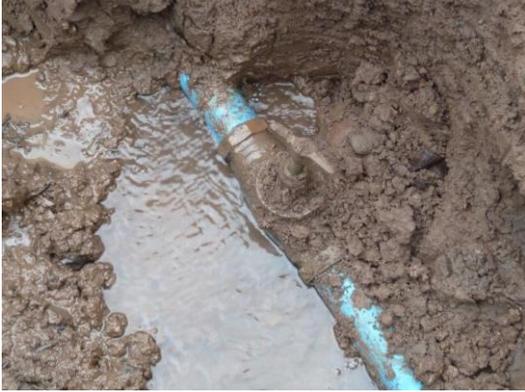
Photo 5: leak on stoptap 2

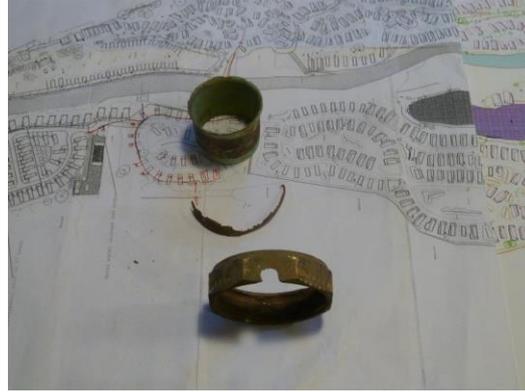
Photo 6: worn compression nut and olive

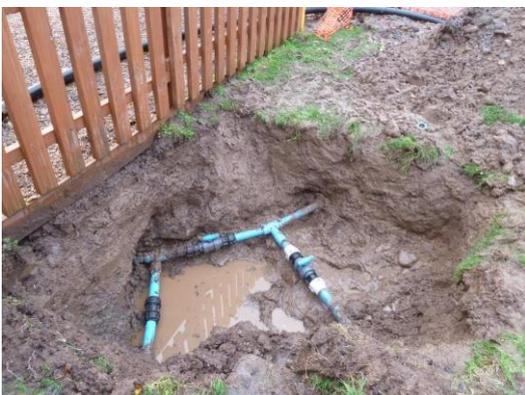
Further testing of the mains in the Cheviot View area confirmed that there was another pipe across the river as the pipework in this area remained live when isolation tests were carried out. Further excavation work revealed a second 63mm MDPE connection (photo 7), with pipework heading towards the river. This was traced out and found to follow the line of the first pipe across the river.

Photo 7 – 2x connections from across river (l/h pipe live, r/h pipe capped off?)

A second new valve was installed on the pipework to allow control of what is believed to be a 'dead' 63 MDPE pipe crossing the river (capped off somewhere?). This is the first pipe that was traced across the river (refer to attached site sketch).

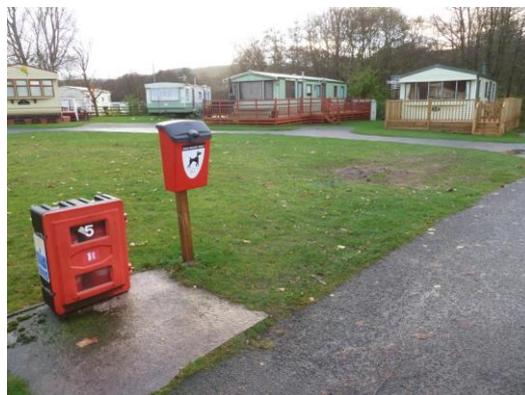
This second pipe crossing the river was traced to the same point as the first, and a trial hole excavated to confirm its location (photo 8). Within the excavation was found an electricity cable and one 63mm MDPE pipe.

Photo 8 – Trial hole (filled in) to right of fire hose

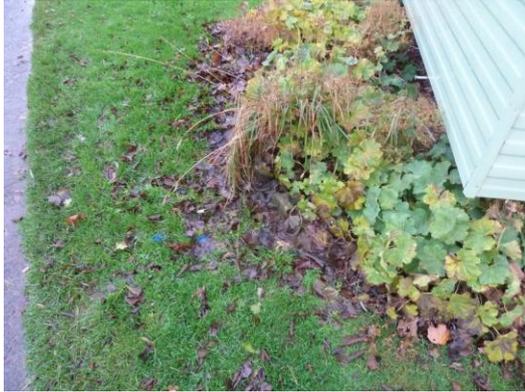
Photo 9 – Line of trace past plot 48

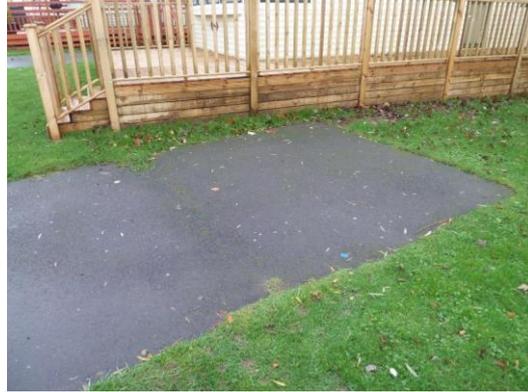
Photo 10 – line of trace through parking space of plot 49
